Case Studies in Forensic Geotechnical and Foundation Engineering

CASE STUDIES IN FORENSIC GEOTECHNICAL AND FOUNDATION ENGINEERING

D.S. “Sax” Saxena, P.E., F.ASCE

ASC geosciences, inc.

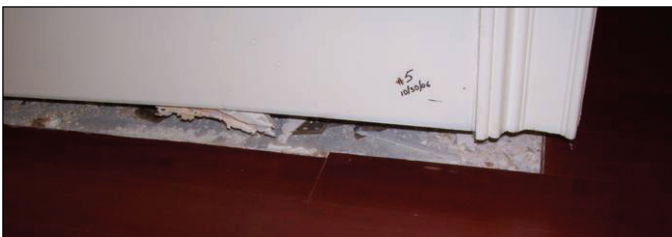
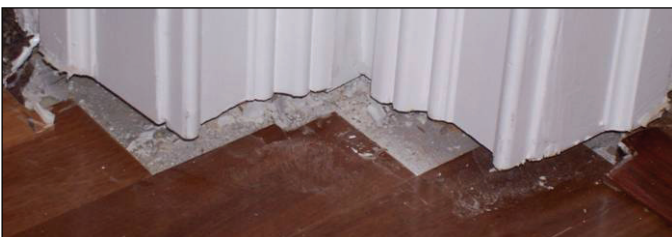
Fig. 1. Two close up views of sinking floor at conference room door.

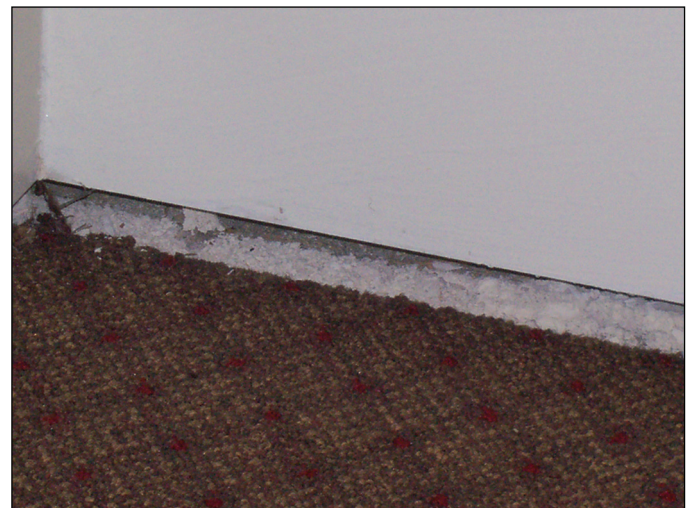
Fig. 2. Close up view of interior partition wall separation from sinking floor slab.

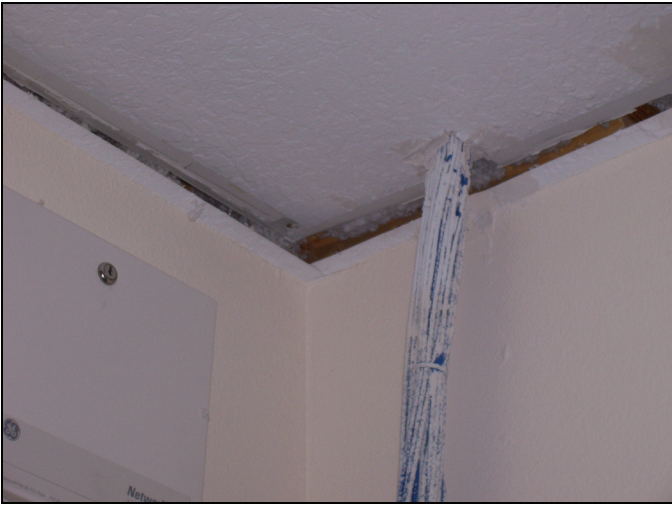
Fig. 3. Close up view of additional separation.

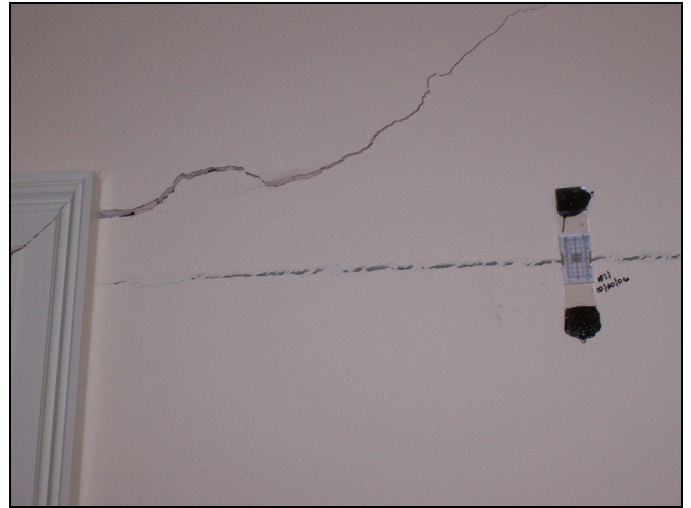
Fig. 4. Close up view of wall crack showing new crack and additional movement.

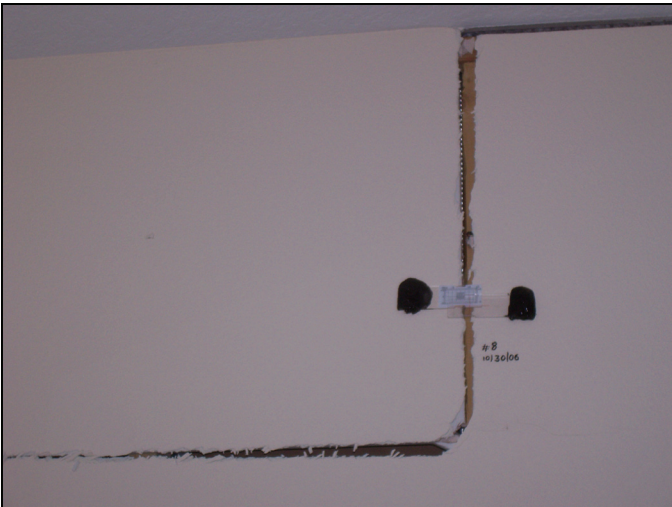
Fig. 5. View of gage No. 8 showing worsened movement.

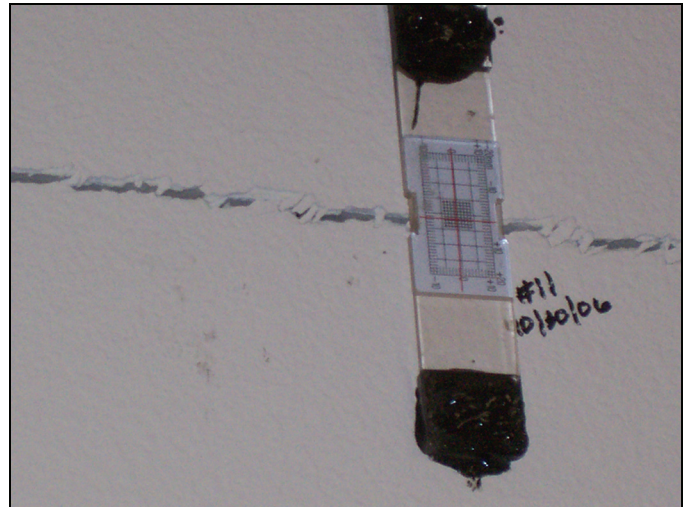
Fig. 6. Gage No.11 in south wall showing worsened movement.

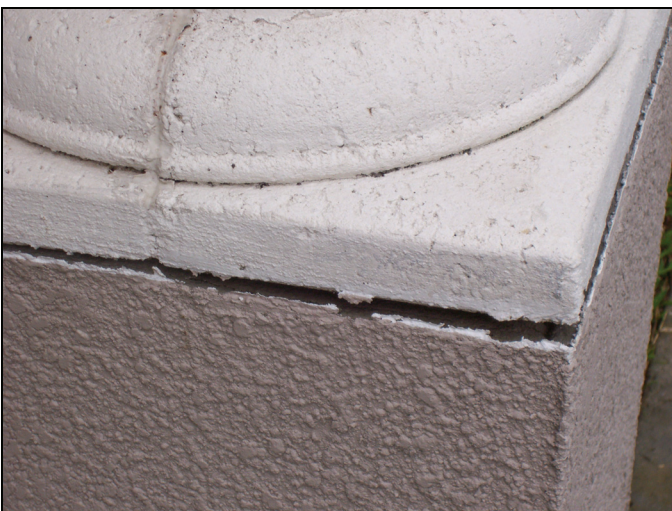
Fig. 7. Close up view of bottom of west side column.

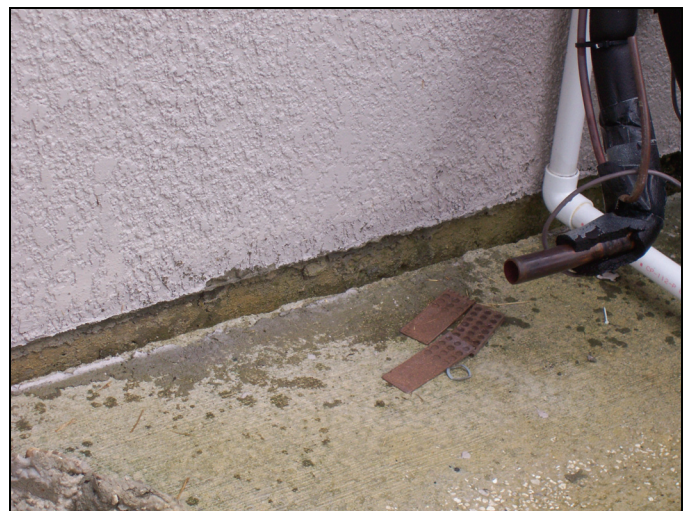
Fig. 8. Separation and sinking of slab along building exterior.

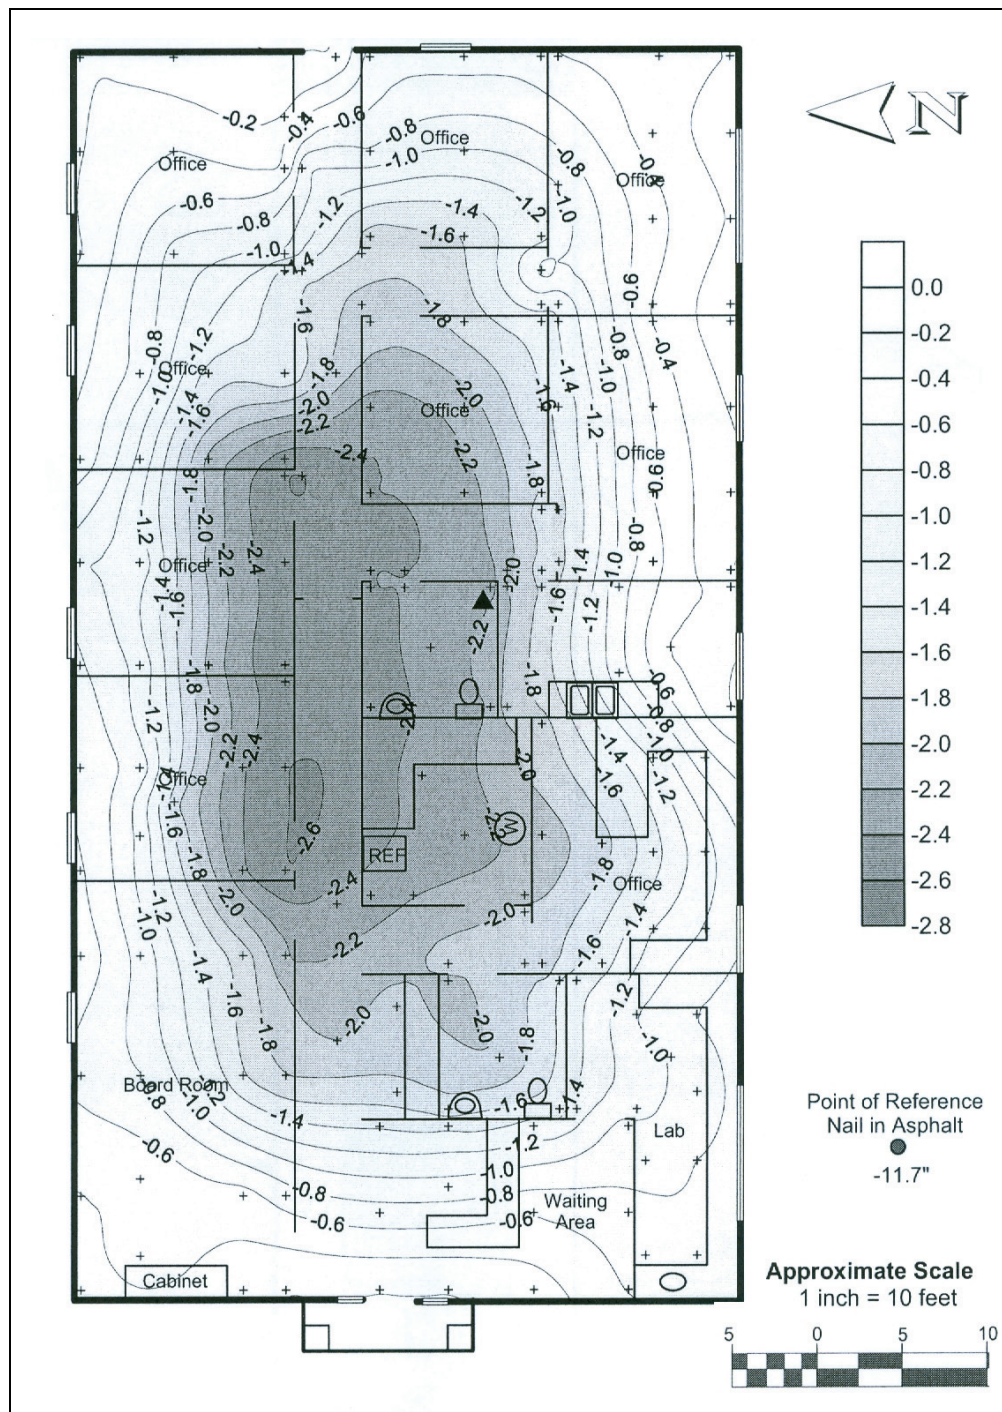
Fig. 9. Floor elevation survey.

1. there were wide spread separations between the walls and the floors, and between partition walls and ceilings. The separations appeared to be greatest toward the center of the building.
2. a floor elevation survey of the building floor slab conducted in March 2007 indicated partial settlement of 3 inches (7.5cms) at the center of the building, as illustrated in Fig. 9.

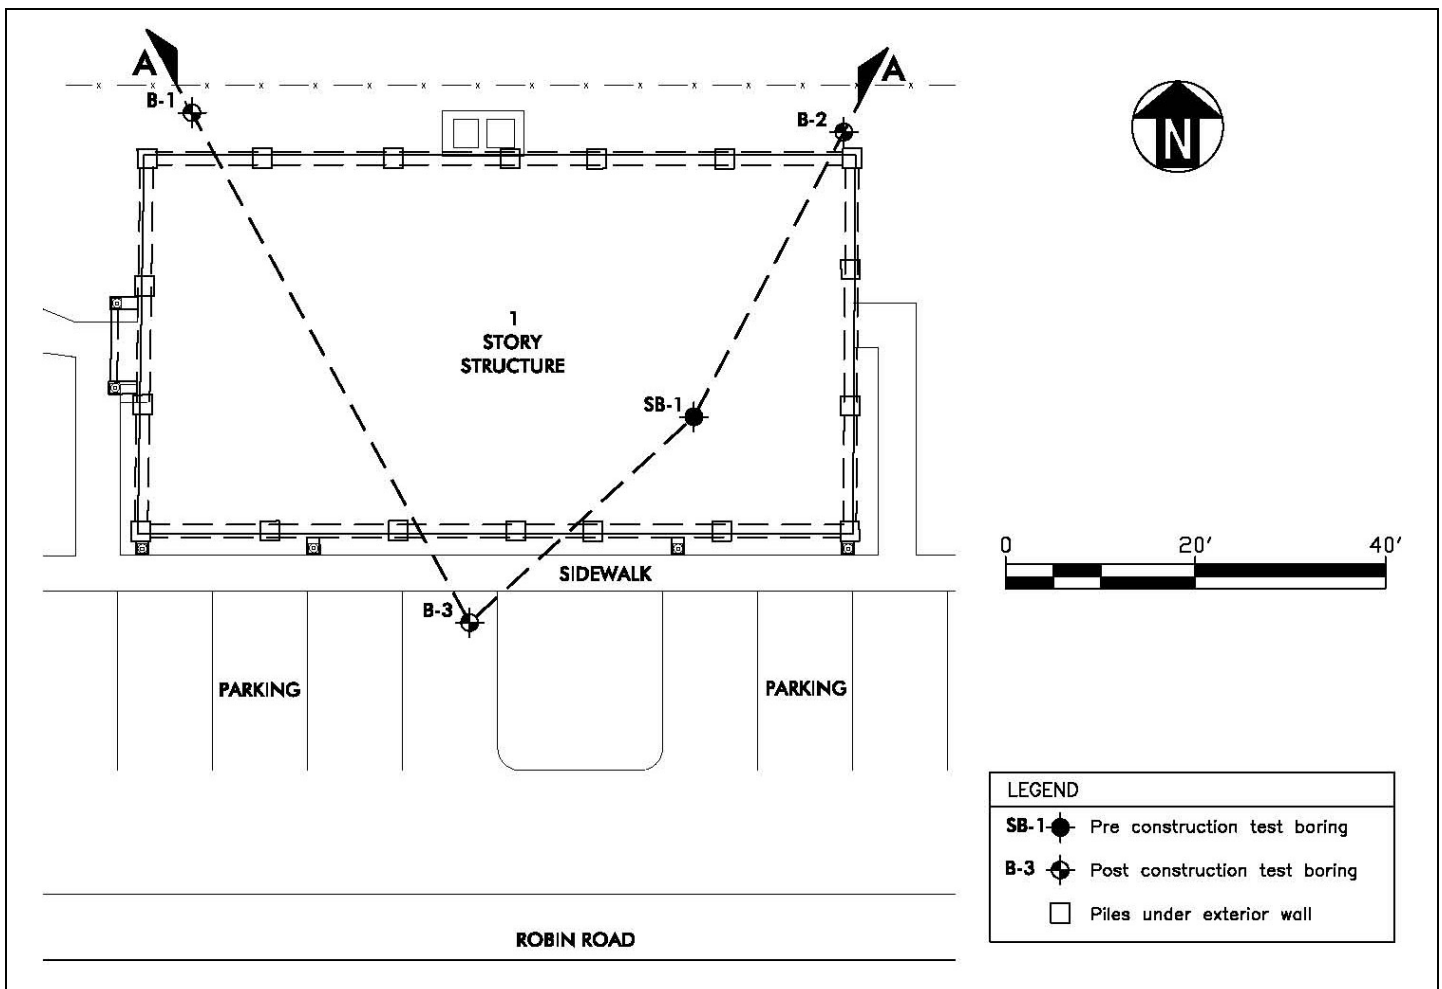
Fig. 10. Building and foundation layout plan with test boring locations.

6. the interior floor slab was only soil supported and not structural (with interior grade beam supported). Refer to Fig. 10 for a building and foundation layout and test boring (SB-1) location plan.

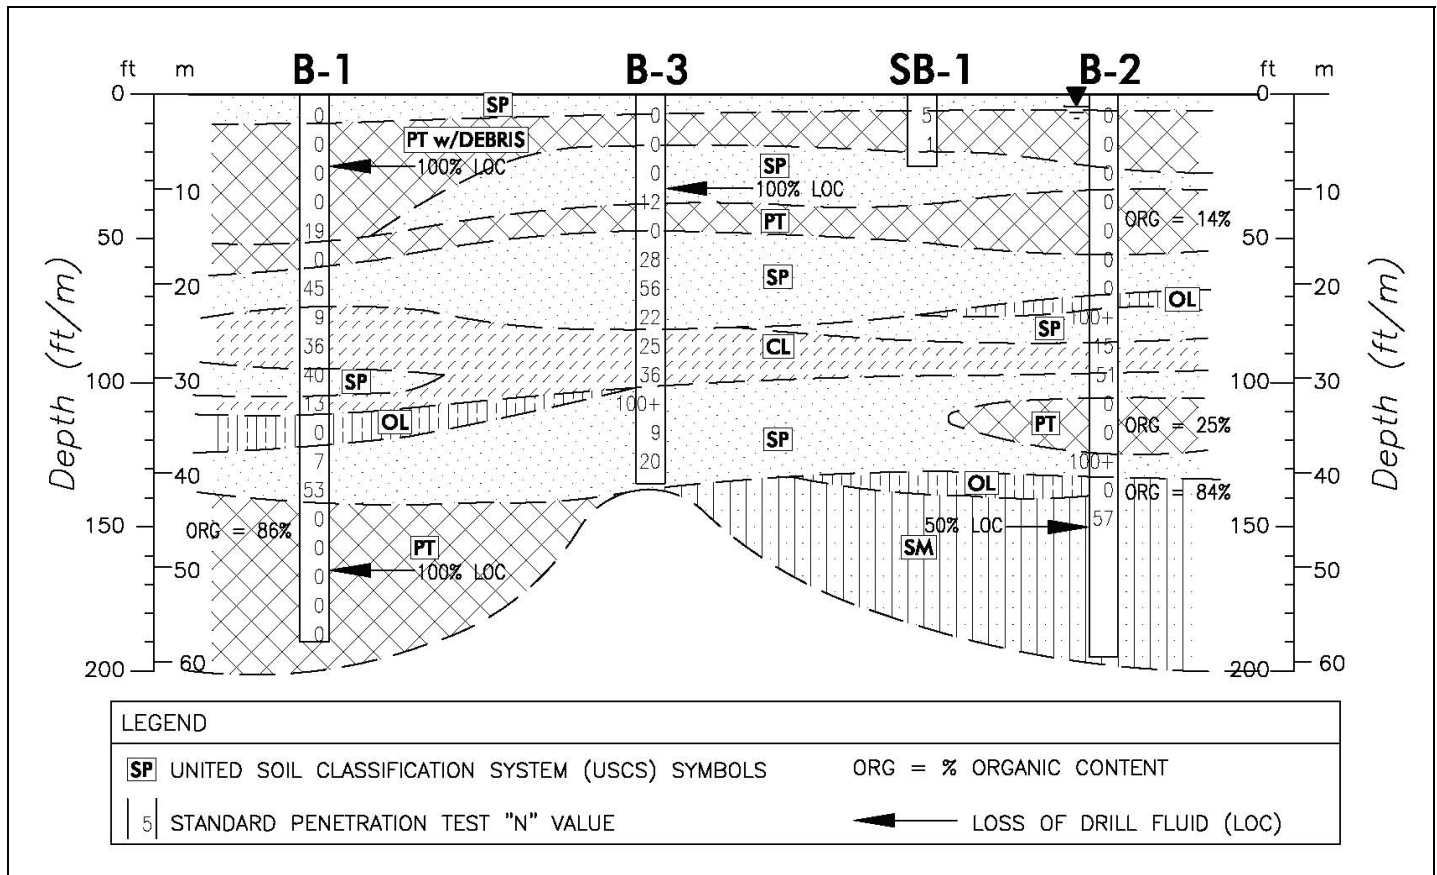
2. upper fill soils were mixed with debris underlain by predominately organic soils with organic content ranging from 5% (at 80 ft depth) to 18.5% (at 60 ft depth) and 85% (at 135 ft depth).
3. no limestone was encountered to the termination depth of 135 ft (43.0m) to 190 ft (60.0m). Project site stratigraphy showing internal erosion and solution features is illustrated in Fig. 11.

Fig. 11. Project site stratigraphy showing internal erosion and solution features.

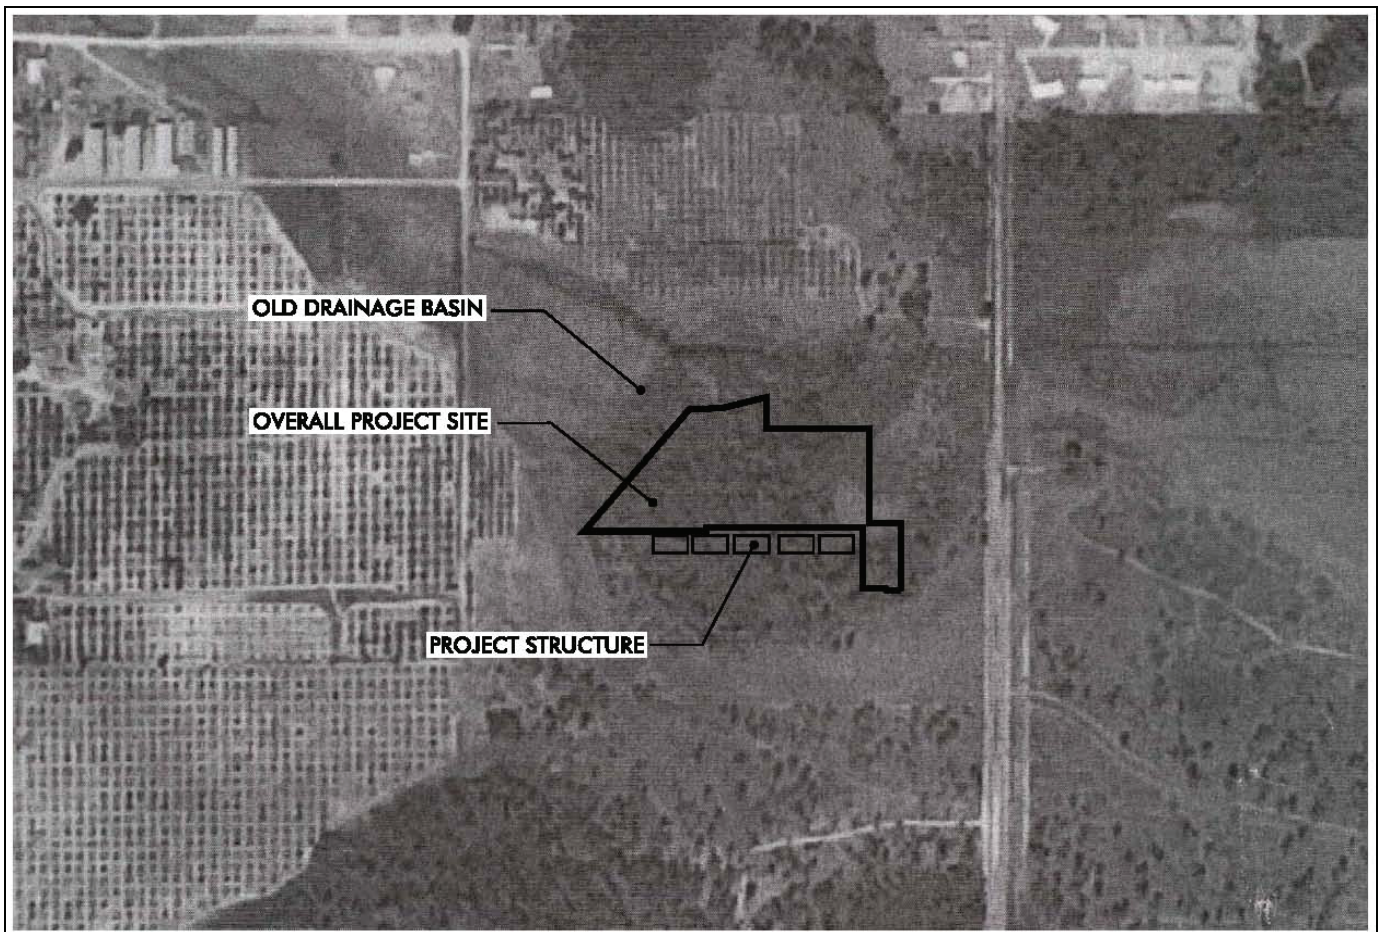
4. damage to the building is the result of factors including consolidation of significant factors including consolidation of significant depth of very loose organic soils (located within a large relic sinkhole) along with the consolidation of buried debris located within or just below the develop fill soils and loading street zone.
5. the old aerial photographs from 1941 through 2005 showed the wetland feature and confirmed that the building was constructed in a wetland drainage basin area over deposits of very deep, very loose organic soils. An aerial of the property taken in 1952, with the building and overall project site superimposed, is illustrated in Fig. 12.

Fig. 12. Site aerial photograph of 1952 illustrating drainage basin and resulting relic sinkhole.

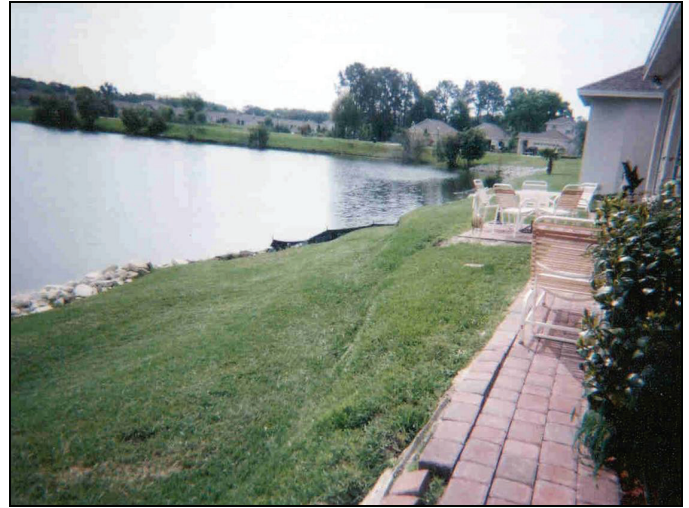
Fig. 14. View of backyard and subsided slope looking south.

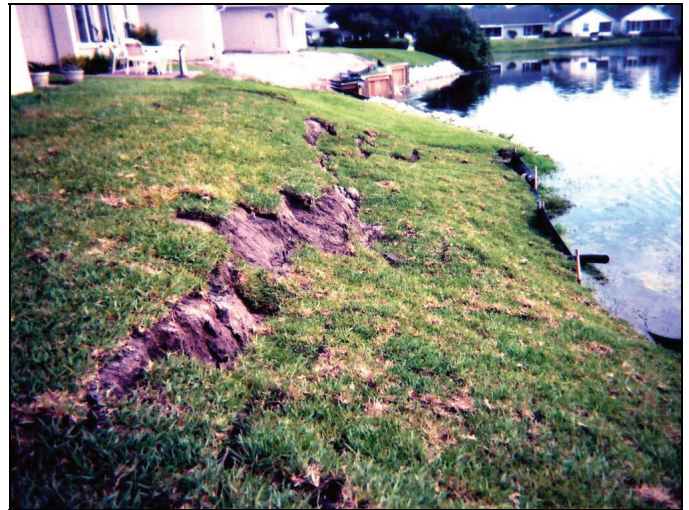
Fig. 16. Reoccurrence of slope failure in finished backyard.

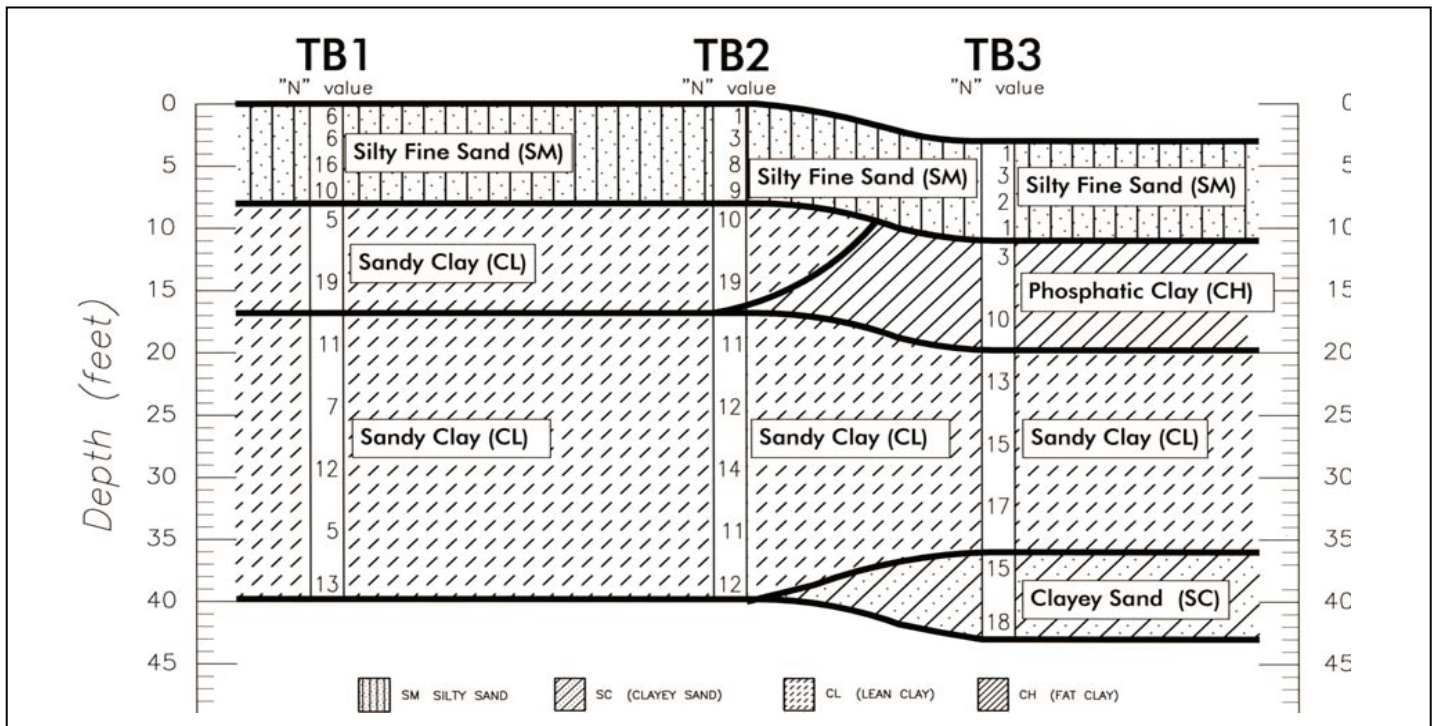
Subsurface conditions beneath the site were evaluated by advancing several test borings. Typical subsurface conditions, as illustrated in Fig. 17, consisted of very soft, loose low strength subsoils to 15 ft depth. These low strength subsoils consisting of highly plastic clays (mc 113%, LL-107, PI-89) which were unstable under the weight of the additional fill material.

Fig. 17. Subsurface stratigraphy identifying delineation of compressible phosphatic clay.

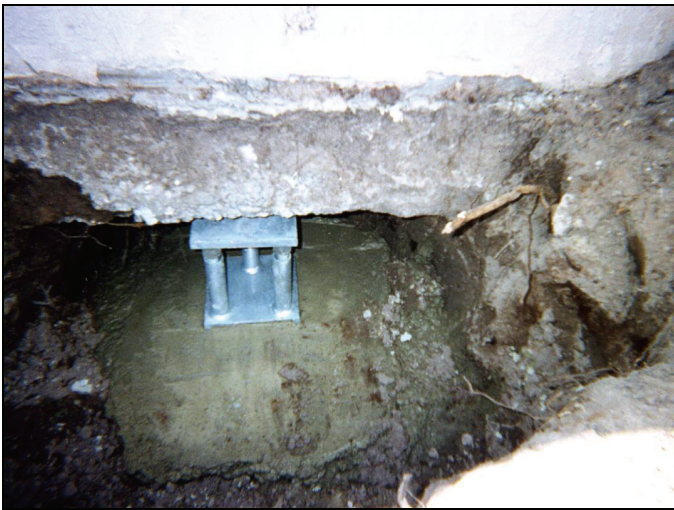
Fig. 18. View of support cap and bracket assembly under the footing.

1. installation of helical anchor piers under the exterior wall footing, along the back of the house, for the underpinning stabilization.
2. installation of a helical anchor bulkhead to stabilize the backyard along the lake.

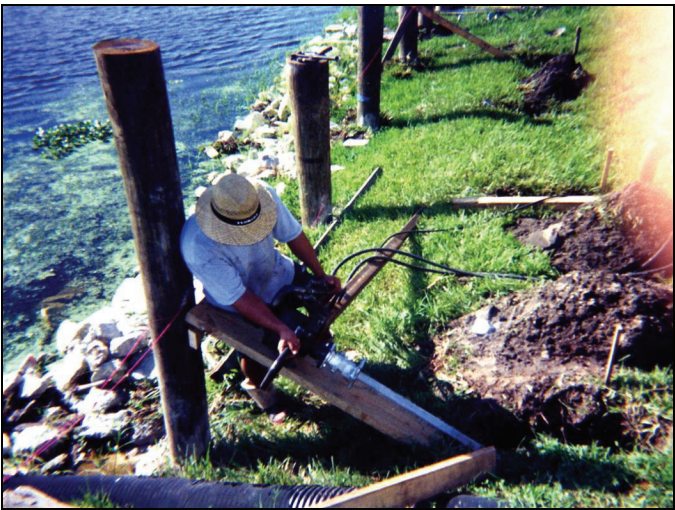
Fig. 19. Hydraulic set-up for achieving torque/resistance capacity.

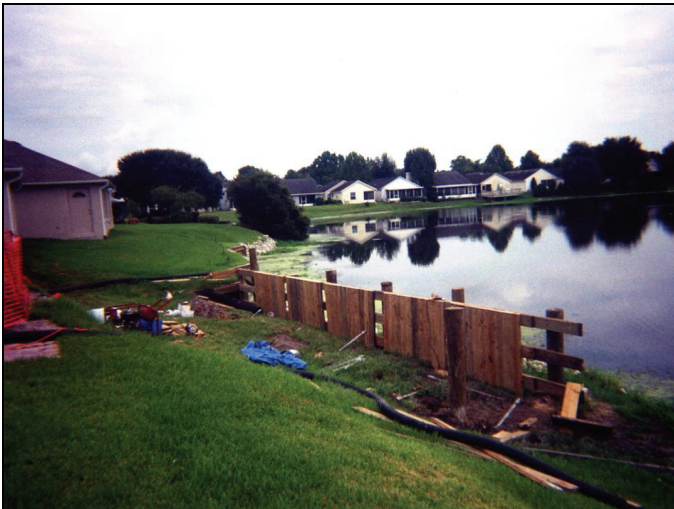
Fig. 20. View of bulkhead construction looking North.

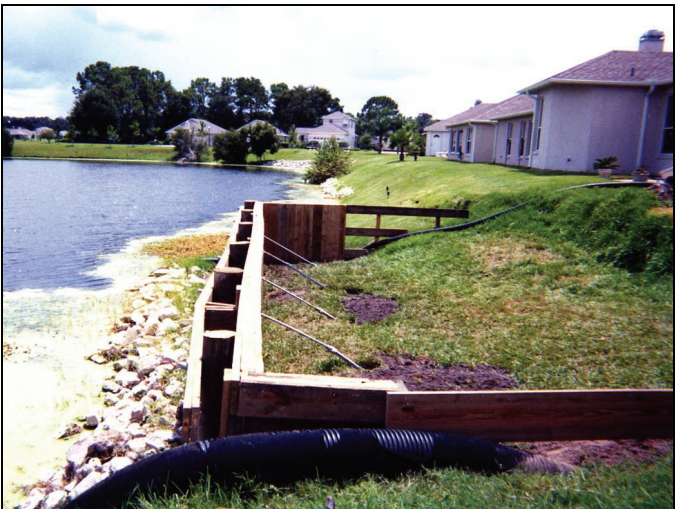
Fig. 21. View of the completed timber bulkhead looking South.

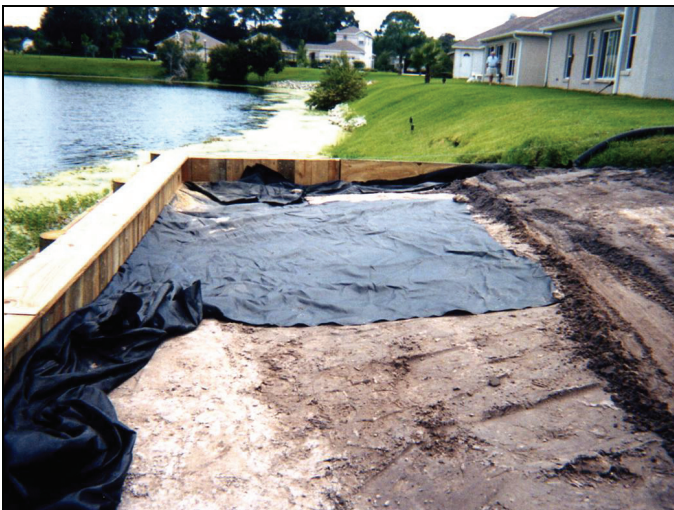
Fig. 22. Geotextile being anchored into fill.

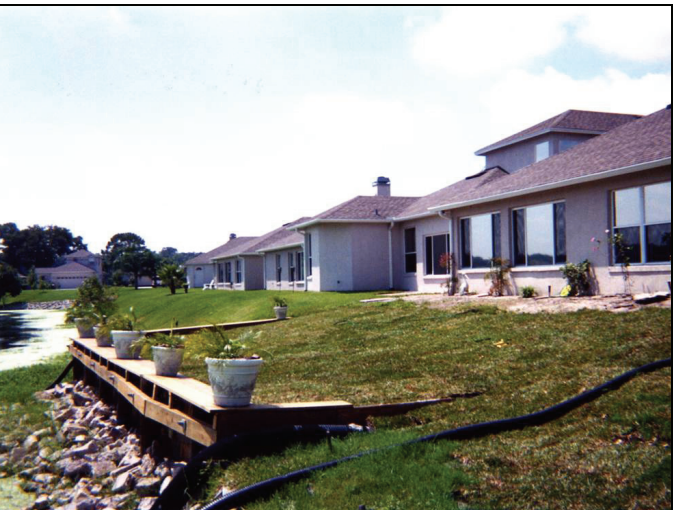
Fig. 23. View of completed bulkhead and restored backyard.
